**Flood Control Project Maintenance
Levee Inspections**
LMA District Cover Sheet
Spring 2012 Levee Inspection Results

Reclamation District No. 2060 Hastings

Levee Inspection Report By Mile - Spring 2012

Waterway							Bank	Unit Miles	Inspection Start/End	Inspector	
Unit No. 01 Lindsey Slough							Left	6.94	03/22/2012 03/22/2012	Herman Phillips	
LMR No.	Levee Mile		Category	Item	Location	Rating	Action/Comment	GPS Latitude/Longitude		Issue No.	
	Start	End						Start	End	Photo	
1			Earthen Levee	Emergency Supplies & Equipment	CR	A Ma		° °	° °	10	
DWR ID: DWR_RD2060_01_s_2012_10											
2			Earthen Levee	Operations & Maintenance Manuals	CR	M Ma		° °	° °	11	
DWR ID: DWR_RD2060_01_s_2012_11											
3			Earthen Levee	Flood Preparedness & Training	CR	A Ma		° °	° °	12	
DWR ID: DWR_RD2060_01_s_2012_12											
4	0.00	0.00	Earthen Levee	Vegetation	LS	M Ma	V1 : Control annual grass and weeds on the levee slopes and easements.	38.247499 ° -121.696301 °	38.247499 ° -121.696301 °	3 Y	
DWR ID: DWR_RD2060_01_s_2012_3											
5	0.00	0.13	Earthen Levee	Vegetation	WS	M Ma	V1 : Control annual grass and weeds on the levee slopes and easements.	38.247294 ° -121.696384 °	38.247336 ° -121.69

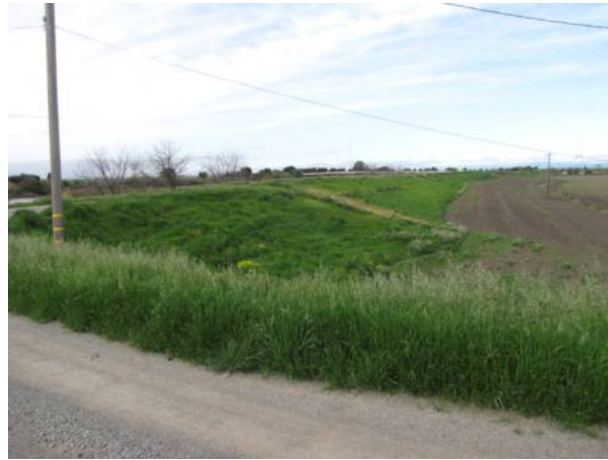
Levee Mile Report Line	4
Start Levee Mile	0.00
End Levee Mile	0.00
Location	Land Side
Category	Earthen Levee
Item	Vegetation

RD 2060 Unit 1 levee mile 0.00 looking downstream from landside shoulder. This photo was taken 3-22-2012.

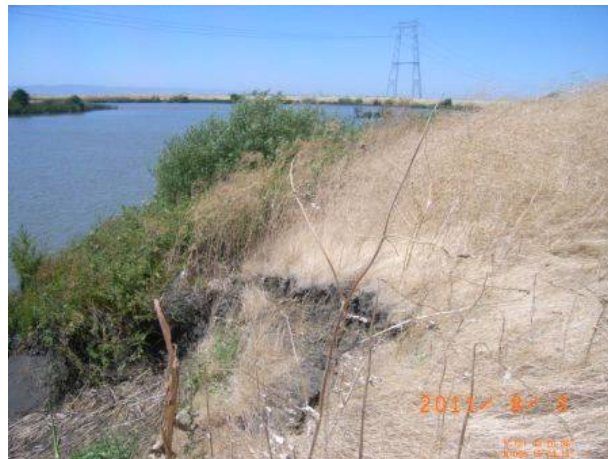
Levee Mile Report Line	7
Start Levee Mile	1.70
End Levee Mile	1.70
Location	Water Side
Category	Supplemental
Item	USACE Erosion Survey

USACE 2011 Photo #1

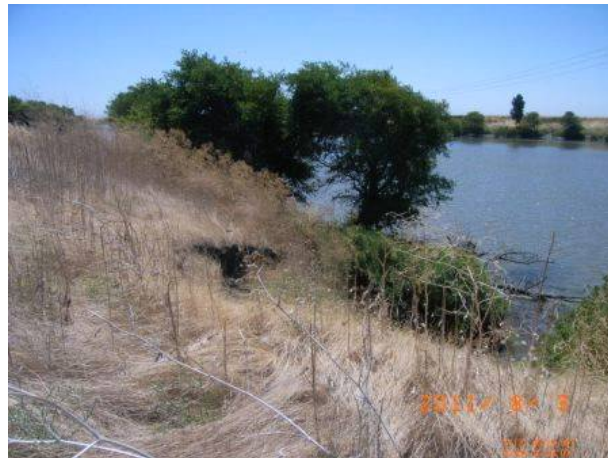
Levee Mile Report Line	7
Start Levee Mile	1.70
End Levee Mile	1.70
Location	Water Side
Category	Supplemental
Item	USACE Erosion Survey

USACE 2011 Photo #2

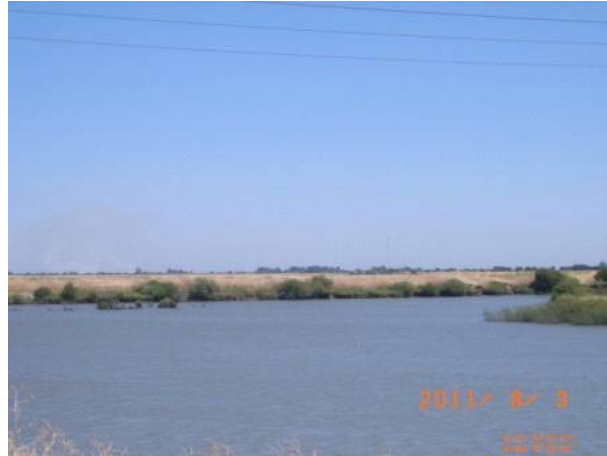
Levee Mile Report Line	7
Start Levee Mile	1.70
End Levee Mile	1.70
Location	Water Side
Category	Supplemental
Item	USACE Erosion Survey

USACE 2011 Photo #3

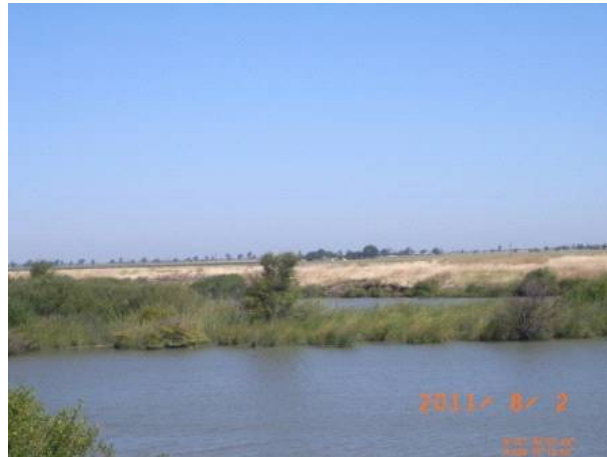
Levee Mile Report Line	8
Start Levee Mile	2.34
End Levee Mile	2.34
Location	Water Side
Category	Supplemental
Item	USACE Erosion Survey

USACE 2011 Photo #1

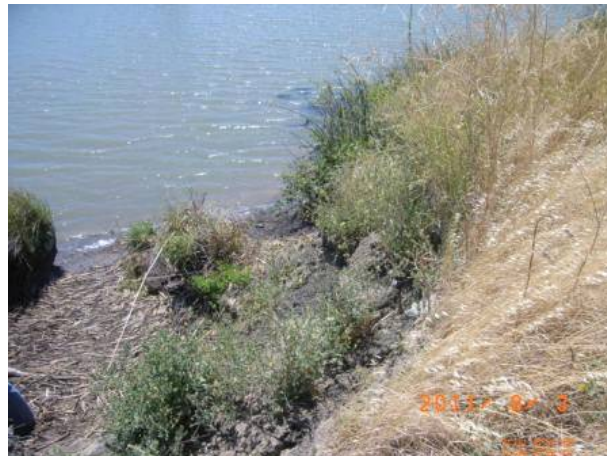
Levee Mile Report Line	8
Start Levee Mile	2.34
End Levee Mile	2.34
Location	Water Side
Category	Supplemental
Item	USACE Erosion Survey

USACE 2011 Photo #2

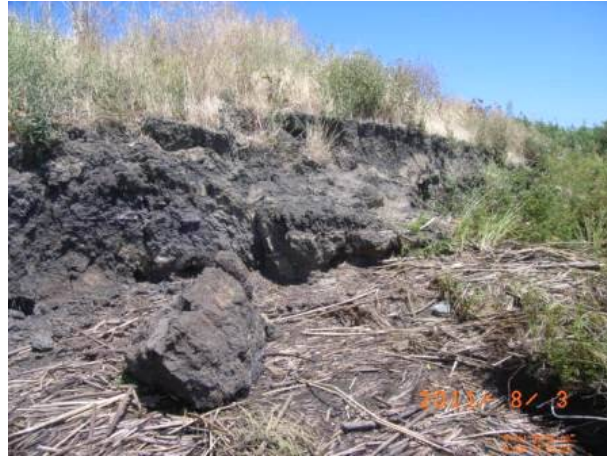
Levee Mile Report Line	8
Start Levee Mile	2.34
End Levee Mile	2.34
Location	Water Side
Category	Supplemental
Item	USACE Erosion Survey
USACE 2011 Photo #3	
phillips_s_20120306_287.jpg

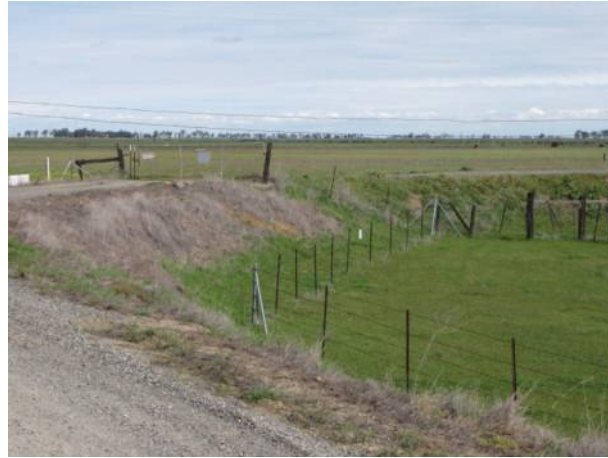
Levee Mile Report Line	1
Start Levee Mile	0.11
End Levee Mile	0.11
Location	Land Side
Category	Earthen Levee
Item	Vegetation

LMR No.	Levee Mile		Category	Item	Location *	Rating ** +	Action/Comment	GPS Latitude/Longitude		Issue No. Photo
	Start	End						Start	End	
1	0.11	0.11	Earthen Levee	Vegetation	LS	A	V1 : Control annual grass and weeds on the levee slopes and easements.	38.276176 ° -121.795873 °	38.276176 ° -121.795873 °	7 Y
DWR ID: DWR_RD2060_02_s_ 2012_7

RD 2060 Looking downstream from levee mile 0.11. This photo was taken 3-22-2012.

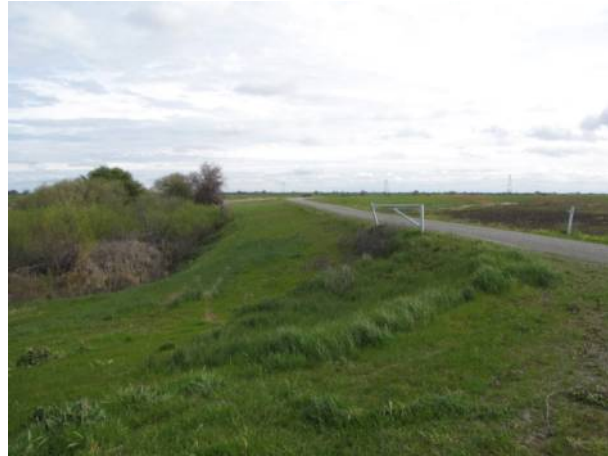
Levee Mile Report Line	1
Start Levee Mile	0.55
End Levee Mile	0.55
Location	Water Side
Category	Earthen Levee
Item	Vegetation
RD 2060 Unit 3 looking downstream from waterside shoulder. Photo taken 3-22-2012.	
phillips_s_20120326_375.jpg

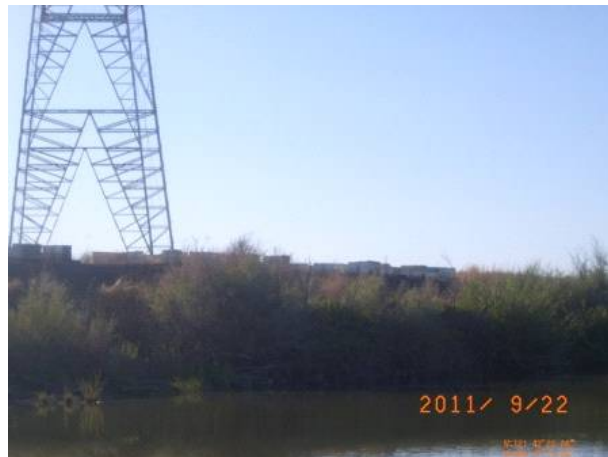
Levee Mile Report Line	2
Start Levee Mile	1.54
End Levee Mile	1.63
Location	Water Side
Category	Supplemental
Item	USACE Erosion Survey
USACE 2011 Photo #1	
phillips_s_20120306_288.jpg

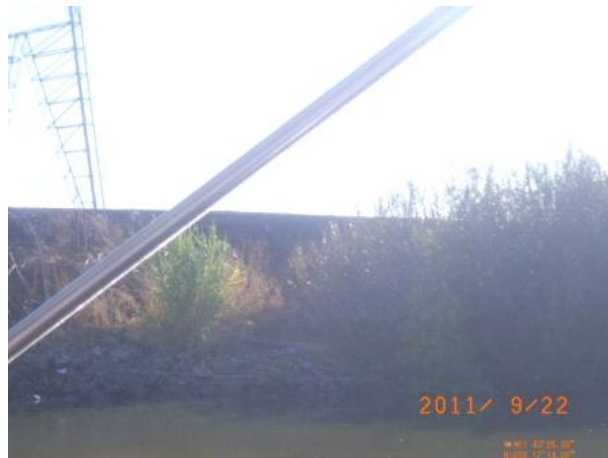
Levee Mile Report Line	2
Start Levee Mile	1.54
End Levee Mile	1.63
Location	Water Side
Category	Supplemental
Item	USACE Erosion Survey
USACE 2011 Photo #2	
phillips_s_20120306_289.jpg

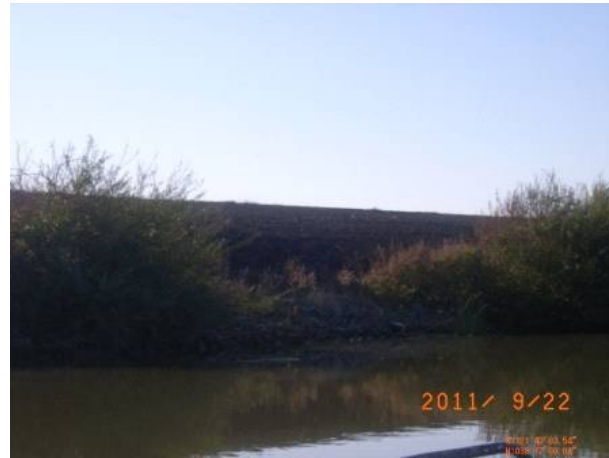
Levee Mile Report Line	3
Start Levee Mile	1.95
End Levee Mile	1.95
Location	Water Side
Category	Supplemental
Item	USACE Erosion Survey

USACE 2011 Photo #1

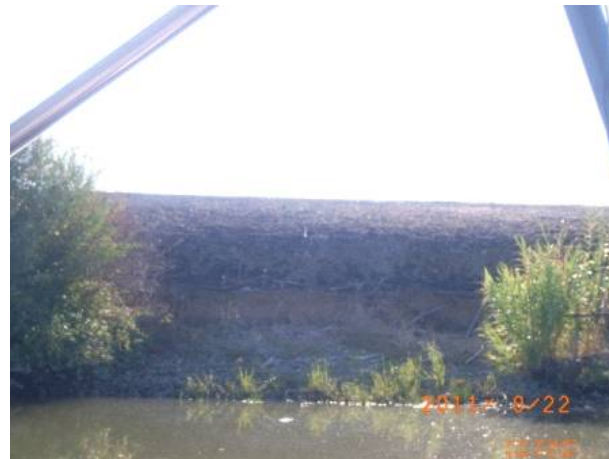
Levee Mile Report Line	3
Start Levee Mile	1.95
End Levee Mile	1.95
Location	Water Side
Category	Supplemental
Item	USACE Erosion Survey

USACE 2011 Photo #2

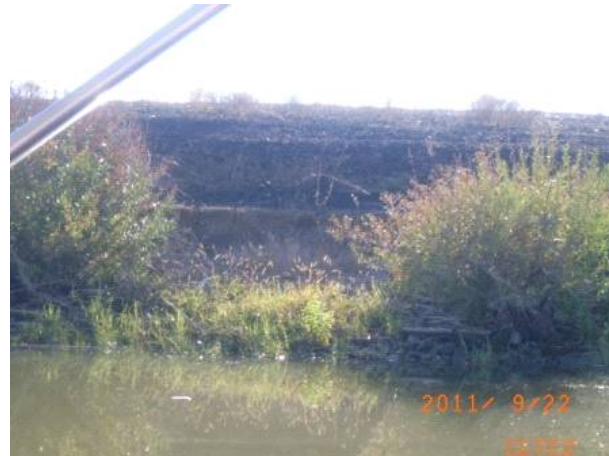
Levee Mile Report Line	3
Start Levee Mile	1.95
End Levee Mile	1.95
Location	Water Side
Category	Supplemental
Item	USACE Erosion Survey

USACE 2011 Photo #3

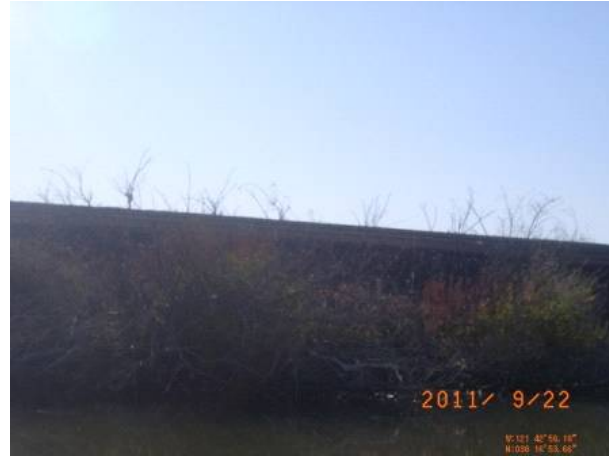
Levee Mile Report Line	4
Start Levee Mile	2.10
End Levee Mile	2.20
Location	Water Side
Category	Supplemental
Item	USACE Erosion Survey

DWR ID: DWR_RD2060_03_s_2012_5										
4	2.10	2.20	Supplemental	USACE Erosion Survey	WS	M Ma	Inspector Comments: 2007 - Geotechnical failure of midside slope and wave wash/scalloping in toe area. Stone revetment upstream and downstream of site. Similar sites are present all along the right bank downstream of this site, most could be repaired with some maintenance. 2010 - Minor new erosion. 2011: No observed change. [2011 Site ID: CHS_22-8_R]	38.282100 ° -121.716817 °	38.281510 ° -121.716319 °	8 Y
DWR ID: DWR_RD2060_03_s_2012_8										
5	2.28	2.48	Supplemental	USACE Erosion Survey	WS	M Ma	Inspector Comments: 2008 - Small scour pockets and mid-slope wave wash. 2010 - More vegetation growth, could be fixed through maintenance. 2011: site extended downstream. new erosion. [2011 Site ID: CHS_22-6_R]	38.280377 ° -121.714633 °	38.278306 ° -121.712722 °	10 Y
DWR ID: DWR_RD2060_03_s_2012_10

USACE 2011 Photo #1

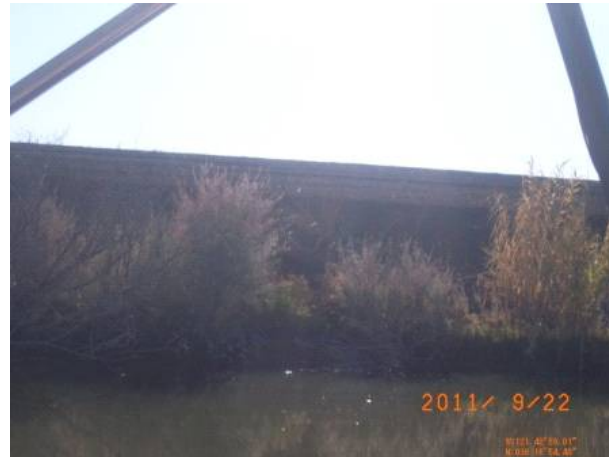
Levee Mile Report Line	4
Start Levee Mile	2.10
End Levee Mile	2.20
Location	Water Side
Category	Supplemental
Item	USACE Erosion Survey

USACE 2011 Photo #2

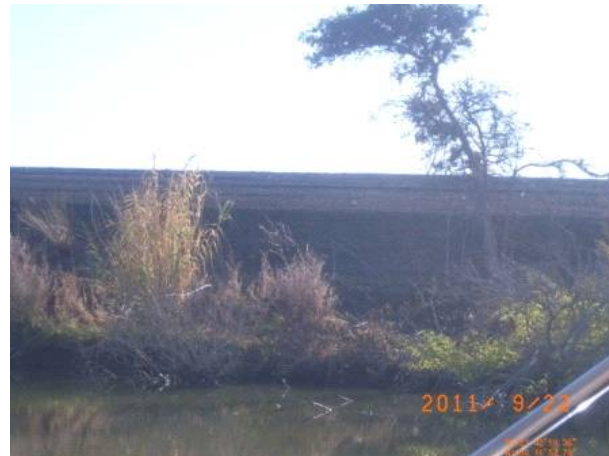
Levee Mile Report Line	4
Start Levee Mile	2.10
End Levee Mile	2.20
Location	Water Side
Category	Supplemental
Item	USACE Erosion Survey

USACE 2011 Photo #3

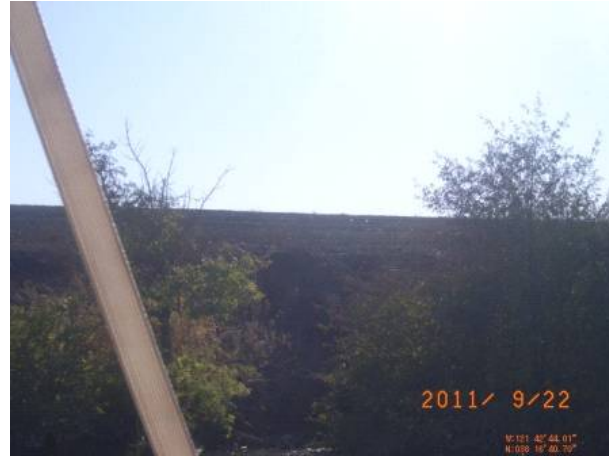
Levee Mile Report Line	5
Start Levee Mile	2.28
End Levee Mile	2.48
Location	Water Side
Category	Supplemental
Item	USACE Erosion Survey

USACE 2011 Photo #1

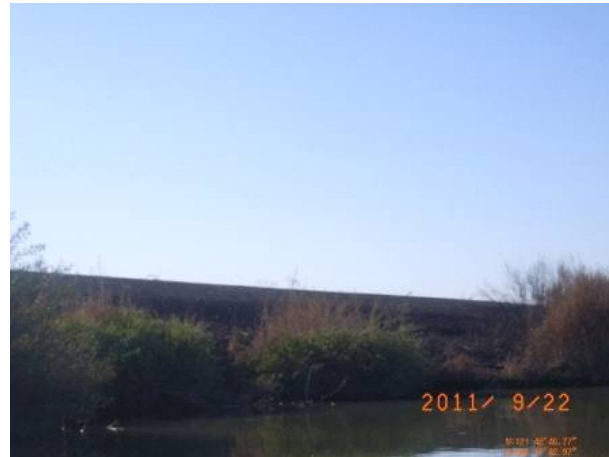
Levee Mile Report Line	5
Start Levee Mile	2.28
End Levee Mile	2.48
Location	Water Side
Category	Supplemental
Item	USACE Erosion Survey

USACE 2011 Photo #2

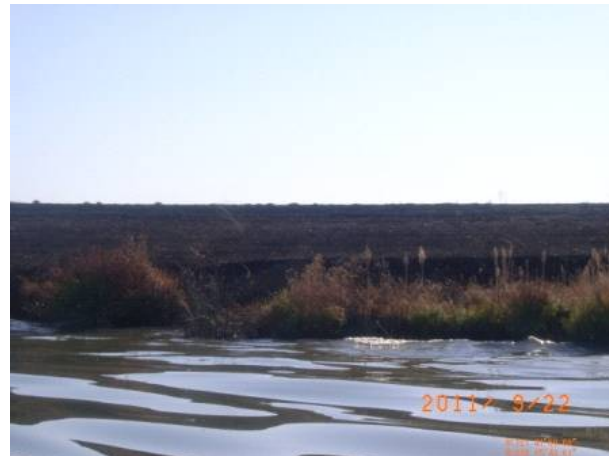
Levee Mile Report Line	9
Start Levee Mile	3.67
End Levee Mile	3.88
Location	Water Side
Category	Supplemental
Item	USACE Erosion Survey

USACE 2011 Photo #1

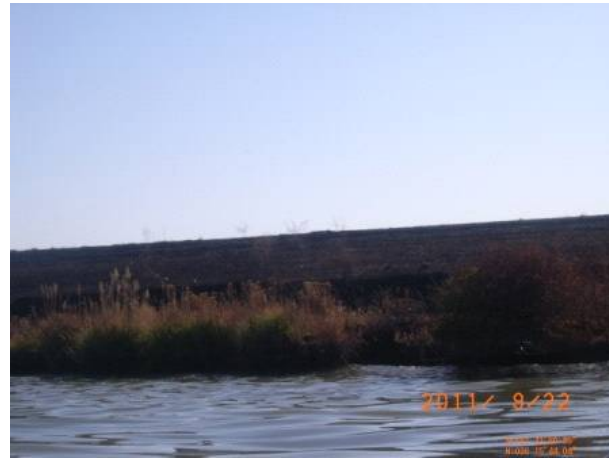
Levee Mile Report Line	9
Start Levee Mile	3.67
End Levee Mile	3.88
Location	Water Side
Category	Supplemental
Item	USACE Erosion Survey

USACE 2011 Photo #2

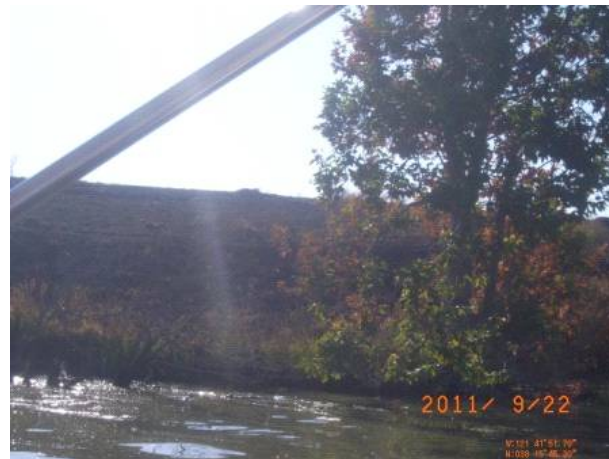
Levee Mile Report Line	9
Start Levee Mile	3.67
End Levee Mile	3.88
Location	Water Side
Category	Supplemental
Item	USACE Erosion Survey

USACE 2011 Photo #3
